National Aerospace Laboratory NLR

NLR-TP-2002-289

# **Material-based failure analysis of a helicopter rotor hub**

A Lynx helicopter from the Royal Netherlands Navy lost a rotor blade during preparation for take-off. The blade loss was due to failure of a rotor hub arm by fatigue. The arm was integral to the titanium alloy rotor hub. An extensive material-based failure analysis covered the hub manufacture, service damage and estimates of service stresses. There was no evidence for failure owing to poor material properties. However, fractographic and fracture mechanics analyses of the service failure, a full-scale test failure and specimen test failures indicated that the service fatigue stress history could have been more severe than anticipated. This possibility was subsequently supported by a separate investigation of the assumed and actual fatigue loads and stresses.

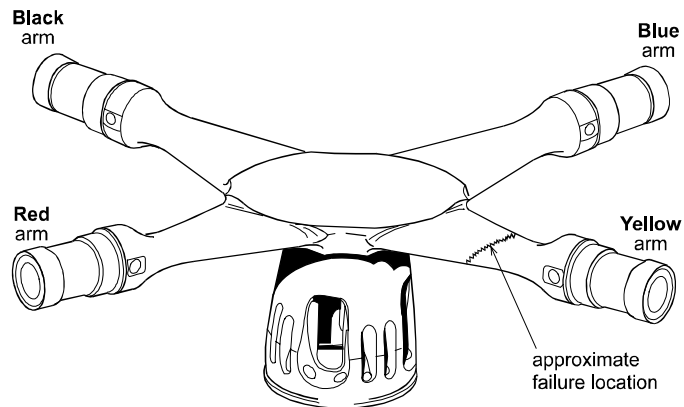
On 10 November, 1998, a Royal Netherlands Navy (RNLN) Lynx helicopter lost a rotor blade during preparation for take-off. The blade loss was due to failure of a rotor hub arm. Figure 1 shows the failure schematically. It occurred in the "yellow" arm of the rotor hub, a monolithic Ti-6Al-4V titanium alloy forging, across an elliptical plain section. Figure 2 is an overview of the outboard fracture surface of the failure. Concentric semi-circular ring markings, so-called "beach markings", on the fracture surface indicated fatigue failure beginning from the arrowed location. This was on the upper surface of the rotor hub arm, towards the trailing edge.

Fig. 1 Failure location in the monolithic rotor hub, a Ti-6Al-4V forging

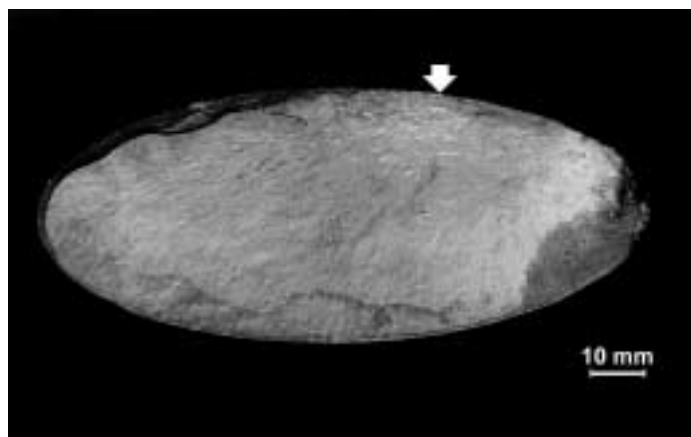
The failure analysis included a check to see whether one of the blind reference holes could have been at the same location as the fatigue origin in the failed yellow arm, see figure 2. It was concluded that this was improbable [2].

Fig. 2 Macro photograph of the yellow arm outboard fracture surface. The failure origin is arrowed

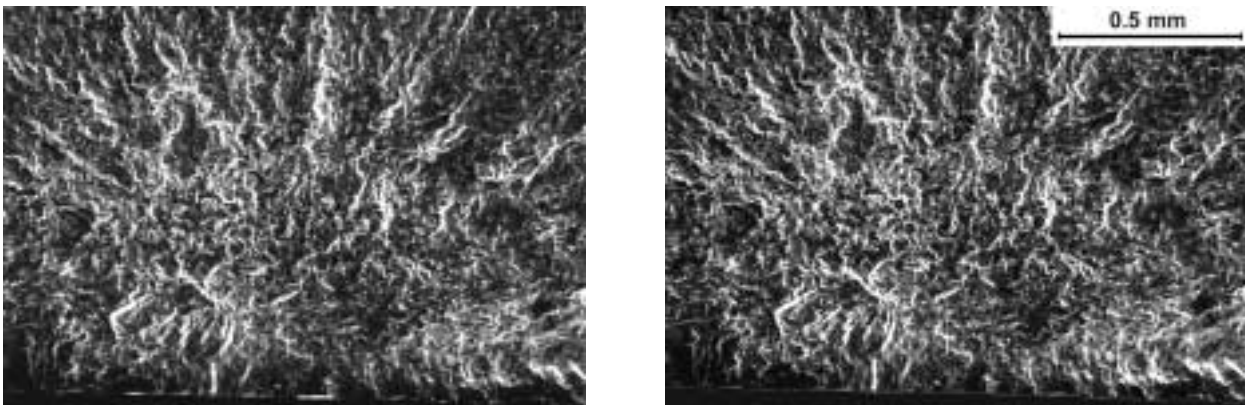
Similar changes in fracture topography were observed for the fatigue origins of the M6 full-scale and M323 specimen test failures. These changes were mapped using combinations of optical and SEM fractography over the magnification range  $30\times - 3000\times$ . Stereo pair SEM fractography was particularly useful in defining the boundaries between the changes in fracture topography: figure 5 is an example, showing the same area as in figure 4.

*Fig. 5 Stereo pair SEM mesofractographs of the fatigue origin on the inboard fracture of the M323 service failure: y-axis tilt  $\pm 5$  , some vertical foreshortening due to x-axis tilt for better visibility of topography changes*

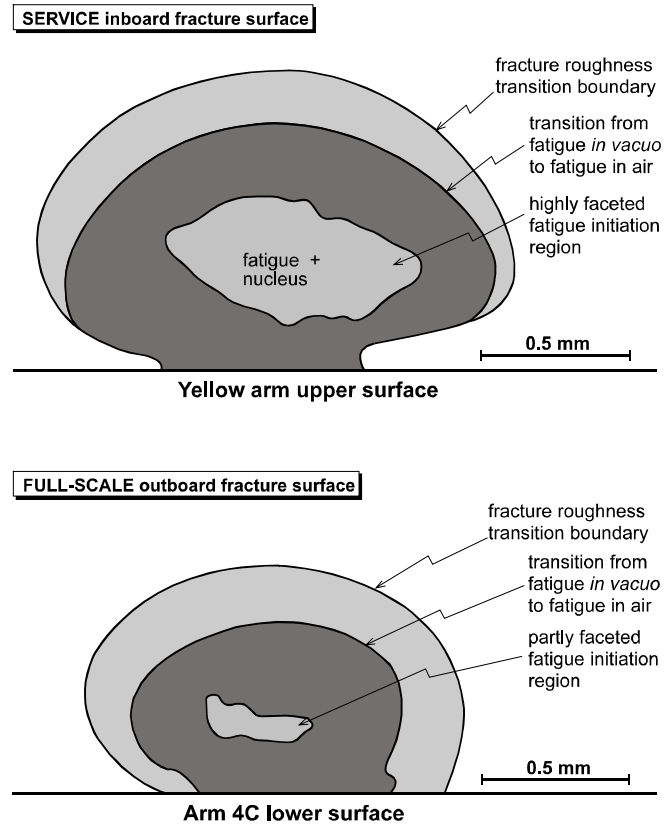
Figure 6 compares schematics of the fatigue origin areas of the service and full-scale test failures. Fatigue nucleation was subsurface owing to surface shot peening (though titanium alloys can show naturally-occurring subsurface fatigue origins at very long lives). Thus the fatigue cracks grew initially in vacuo. When the cracks broke through to the outer surfaces there was a subtle but definite change in fracture topography, namely that the fatigue facets produced in air were more sharply defined than those produced in vacuo. Figure 7 gives an example of this difference, whereby it should be noted that the SEM magnification for the facet produced in air is twice that for the facet produced in vacuo.

At the fracture roughness transition boundary the crack depths,  $a$ , were 1.02 mm for the M323 failure and 0.78 mm for the M6 failure, see figure 6. Substituting these values in equation (3) gives

Fig. 6 Schematics of the fatigue origin areas of the M323 service and M6 full-scale test failures

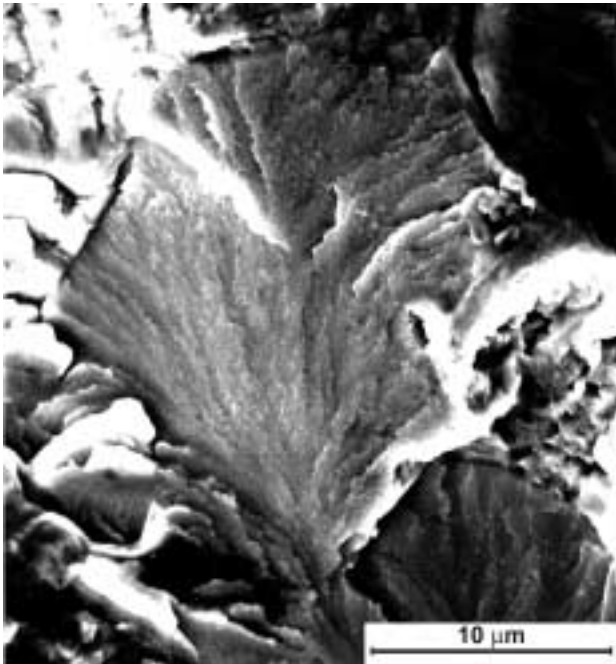
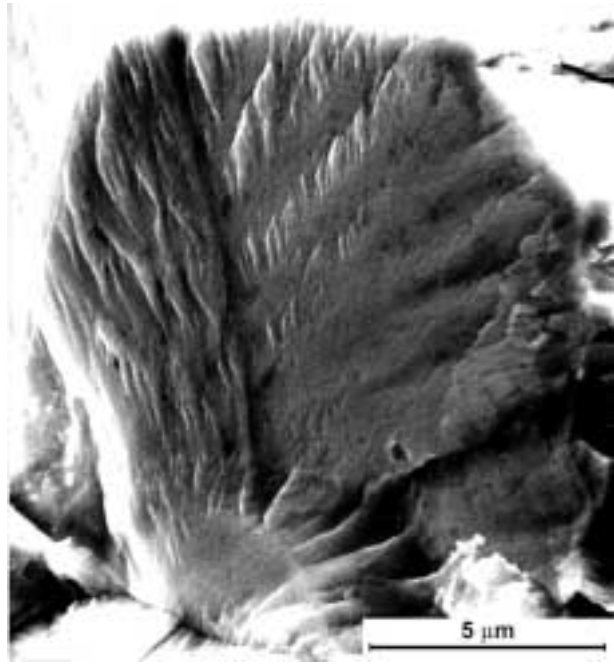
Fig. 7 Microfractographic differences between fatigue facets produced in vacuo and in air  
These details are SEM fractographs of the fatigue origin area of the M323 service failure
